**Inspection Notice**  
**MSA Latchways® Guided Type Fall Arrester**  
 February 2024  
 PLEASE READ AND TAKE ACTION NOW

This Inspection notice is to inform you of a one-time inspection procedure regarding the locking pin on MSA Latchways® Guided Type Fall Arresters (GTFAs) that were manufactured between February 16, 2021 and January 30, 2024. Potentially affected models are listed in Table 1 below.

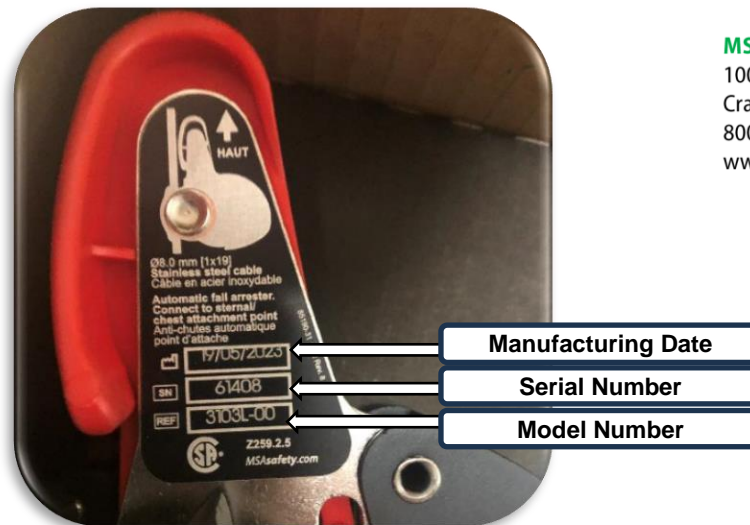
**Figure 2: GTFA Inspection Data**

- 1) **Confirm Model Number and Manufacturing Date** – Refer to Figure 2
  - a. **Model Number**
    - i. Confirm that your model number is listed in Table 1.
    - ii. If your model number is not listed, no further action is needed.
  - b. **Manufacturing Date**
    - i. Confirm that your manufacturing date is between 16/02/2021 and 30/01/2024
    - ii. If the date is outside of this range, no further action is needed.
